[redacted]	**INSPECTION REPORT** *THIS DOCUMENT IS NON-NEGOTIABLE*	**Client Name**	-
		Report No.	
		Inspection Date	Mar 23rd,2026

Product Photo
Supplier:	Shing Yip Gifts (Dongguan) Company Ltd	
Manufacturer:	Shing Yip Gifts (Dongguan) Company Ltd	
Product Name:	PTNSB104 Bebefinn Big flap sound book #2	
PO No.:	N/A	
Item No.:	N/A	
Order Quantity:	5000pcs	
Order unit:	☒ Pcs. ☐ Set ☐ other. Specify:	
Inspection Quantity:	5000pcs	
Reference Sample:	Yes, Sample provided by factory	
Inspection Type:	**Re-inspection**

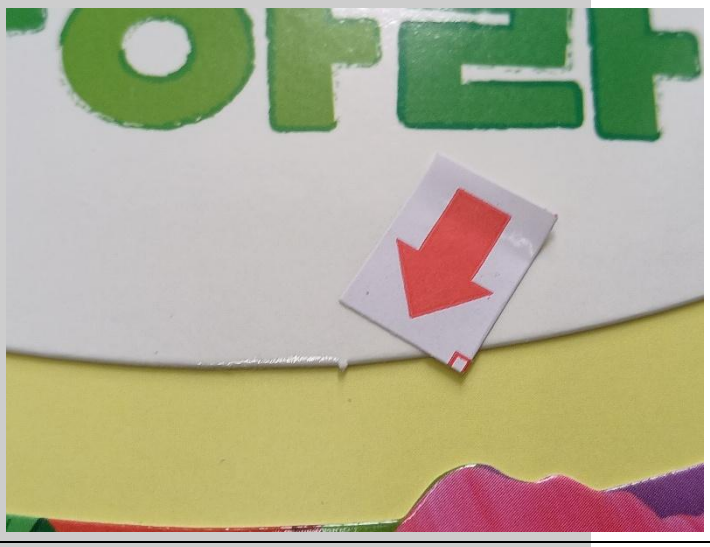
Remark 3: The proportion of edge cutting defects is 100%, which is the same as the sample

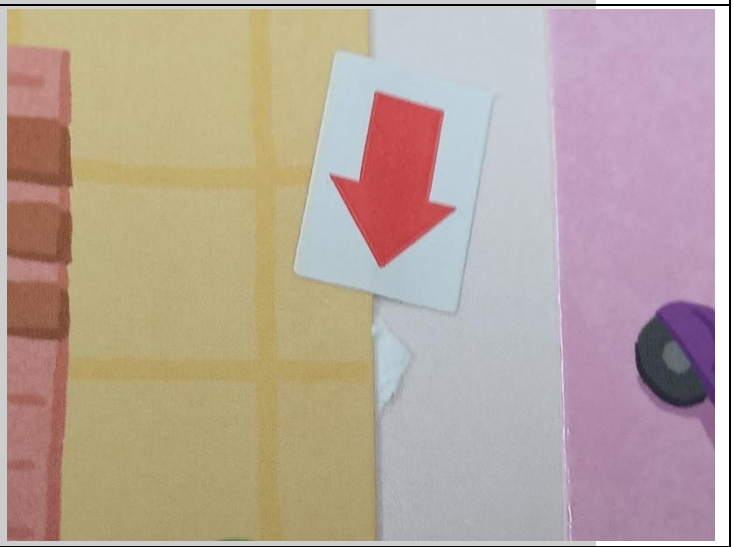
Poor trimming

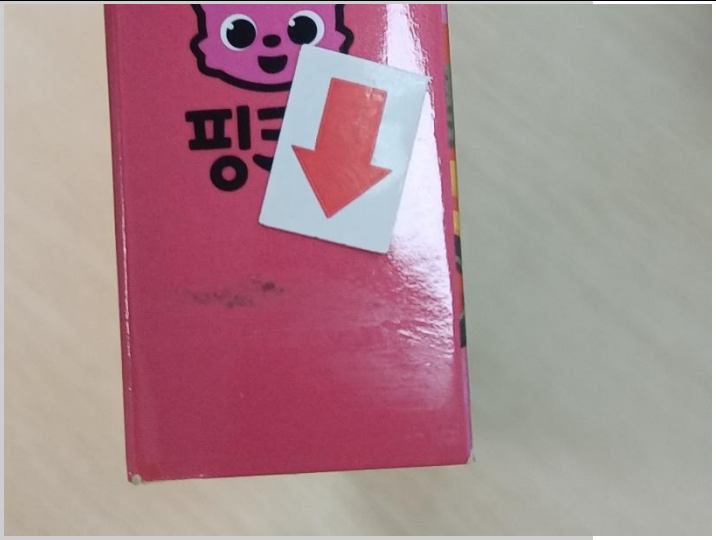
Poor trimming

Poor cutting edge

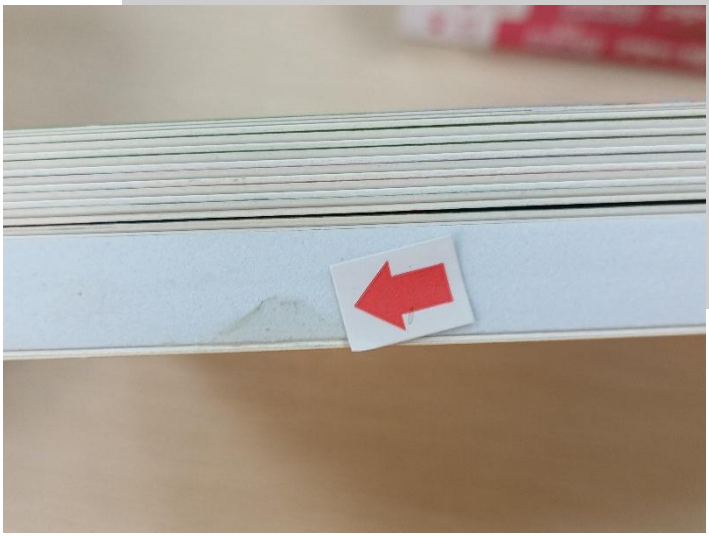
Dirty mark

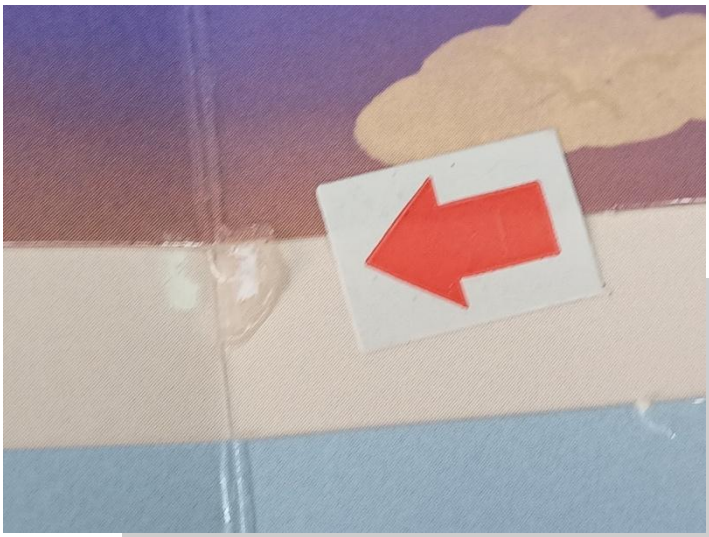
Dirty mark

Adhesive stains

Black dot
